# OIL THOSE TRUNNIONS

Regular lubrication of the front suspension lower trunnions is essential to ensure long component life on a range of 1960s and '70s Triumph models. Kim Henson explains what you need to do and why...

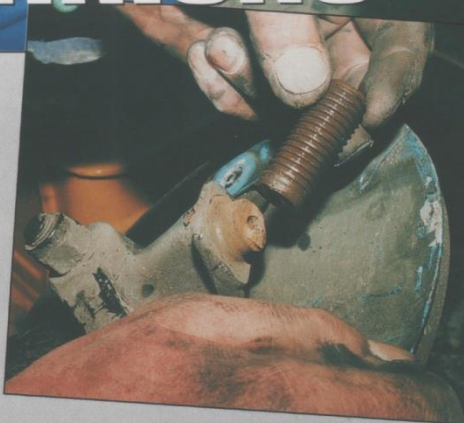
**Above:** Sometimes, as in this case, the threaded section can run for months in a cracked or partially broken condition, then snap completely through without any prior warning. This can obviously be very dangerous and, alas, there's no definite way of telling when it might happen

Worse still, extra strain will be imposed on the threaded section of the vertical link, which can literally break off just above the top of the trunnion. In this case, the suspension will collapse and the front of the car will drop onto the road surface...

Trouble is, there's no way of foretelling when this is about to happen, and a visual examination of the front suspension will not tell you much, although 'stiff' steering is a bad sign... (Incidentally, if the threaded section of the vertical link is bent, movement

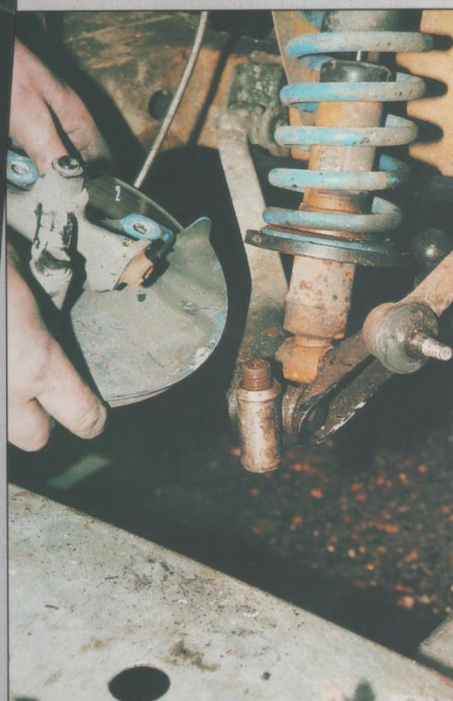
**Right:** This is what happens if you fail to regularly lubricate your Triumph's trunnions! The threaded section of the lower link breaks off just above the trunnion. By an amazing coincidence, Southern Triumph Services were called out to rescue this 'collapsed' Spitfire on the day of our photographic session

The theory of regularly lubricating the trunnions/vertical link threads in this way is fine, but in reality it is a job which is often ignored. So the trunnion/threads run dry, friction between the components is massively increased and the inevitable result is rapid wear. Eventually excessive free play and unwanted movement will accumulate between the trunnion and the threads, resulting in an MoT test failure.

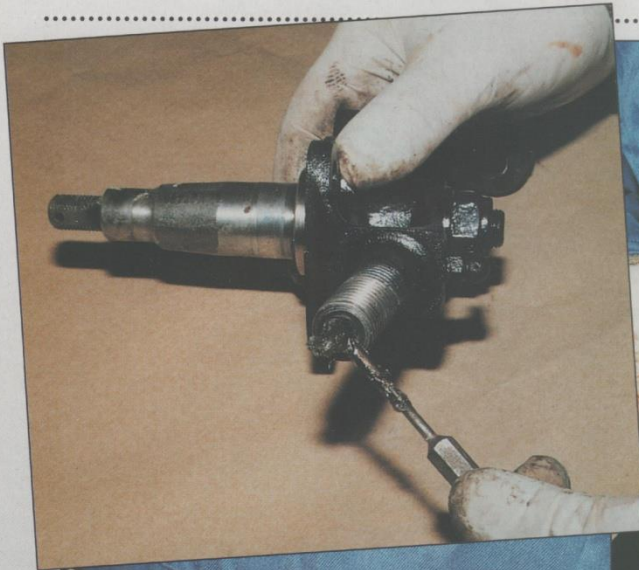
**Top Left:** DO NOT USE GREASE to lubricate the trunnions! This can harden and clog the vertical link's hollow threaded section, preventing proper lubrication of the threads. This defeats the object of greasing them in the first place...

The best insurance against the troubles described is to lubricate the trunnions without fail every 3,000 miles or so. Whatever you do, don't be tempted to use grease instead of the recommended oil; the trouble is that grease tends to harden and clog within the trunion assembly. The threaded sections then, effectively, run 'dry' and rapid wear

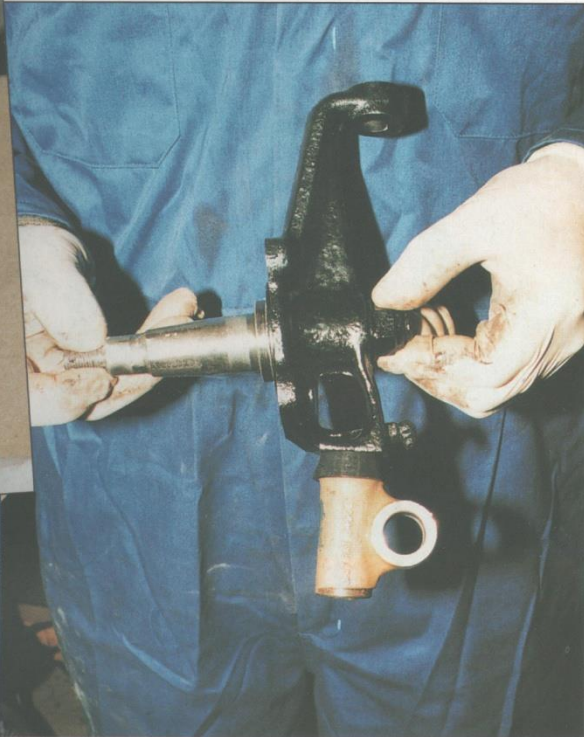
**Bottom Left:** When installing new trunnions and vertical links, 'fill' the trunnion with the correct Hypoid 90/EP 90 gear oil. Note the lubrication nipple in the vertical link; oil flows from this down through the threaded section and into the trunnion

In any event, always pre-lubricate new trunnions with the correct oil, prior to assembly, to give the best possible chance of trouble-free operation and a long working life.

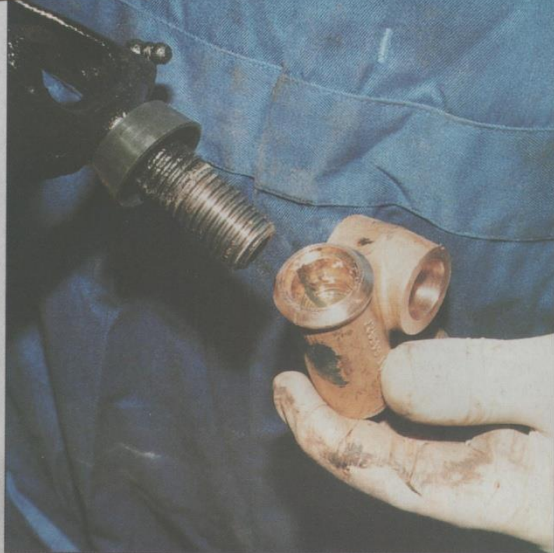
**Above:** This is how the assembled vertical link/trunnion arrangement looks; note the rubber seal above the trunnion (between it and the vertical link). It takes approximately 14 full turns to screw the trunnion onto the link's threads, to achieve the correct 'turning' position

they are well worn. There should be no appreciable free movement (side play) detectable between the trunion and the vertical link when the two are screwed together correctly (approximately 14 full turns to the 'running' position).

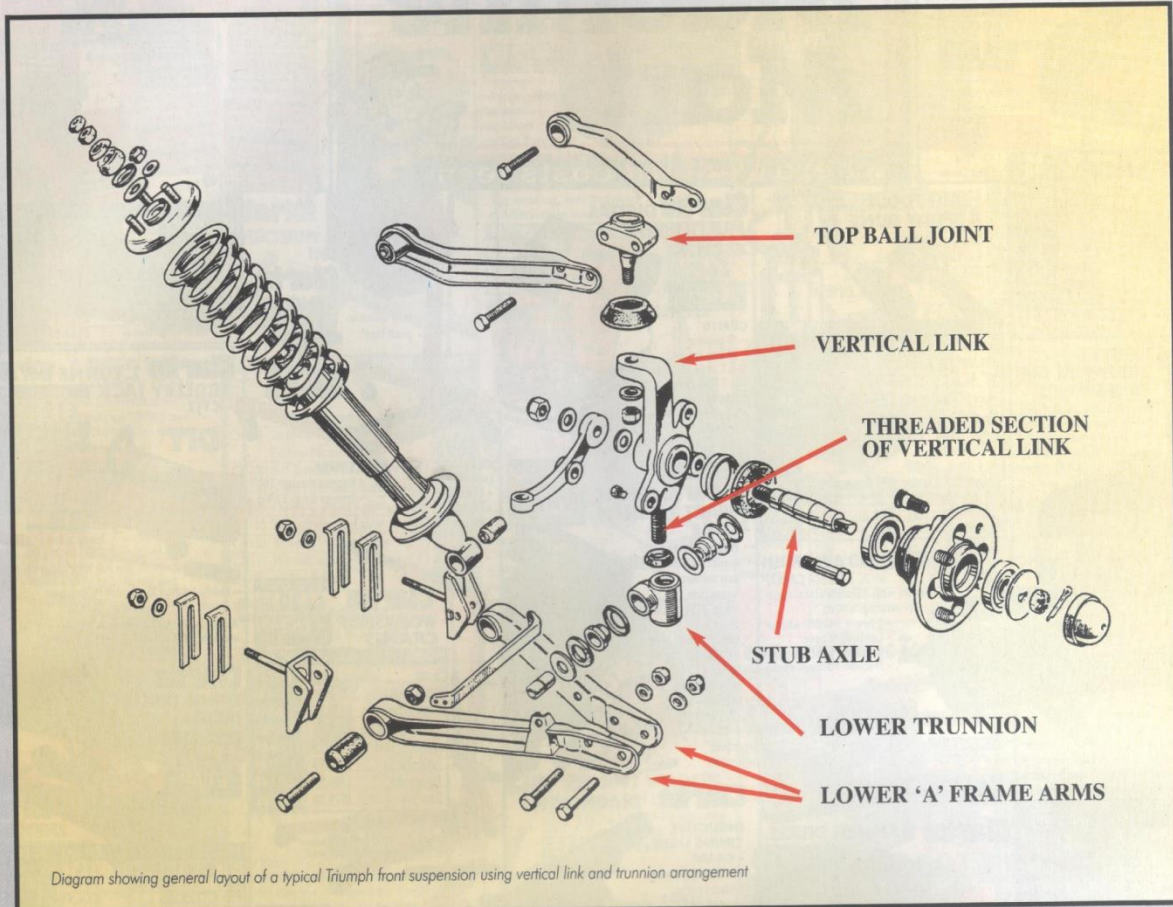
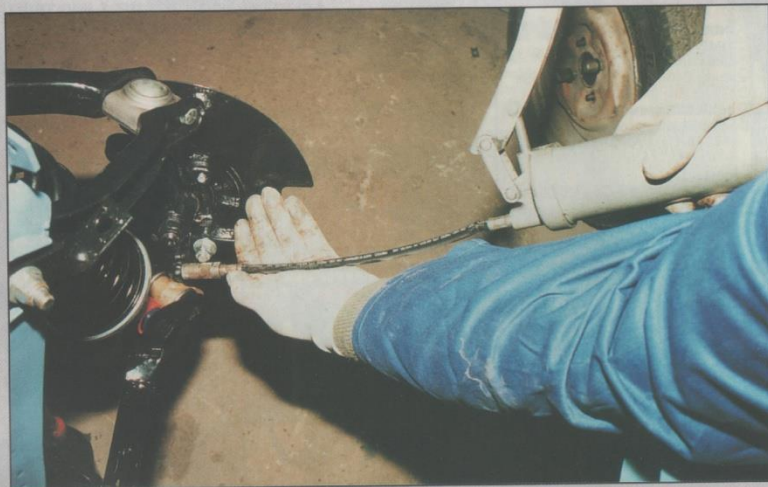
**Above:** During routine maintenance (ideally, at least every 3,000 miles), pump Hypoid 90/EP 90 oil into the lubrication nipple on the inner face of the vertical link, until it emerges from between the trunion and the link. This helps to ensure smooth operation and a long life

To carry out the oiling is straightforward; a lubrication nipple may already be installed on the 'inside' face of the vertical link, or you may encounter a blanking plug — which needs to be unscrewed and replaced by a nipple. Lubricant is applied via an oil gun (an ordinary grease gun cleaned out filled with

the correct oil will do) — 'fill' the trunnion assembly until oil is seen to exude from around the joint between the vertical link's threads and the trunnion.
