Triumph 2000/2500

Buyer's Checklist

TRIUMPH 2000/2500/2.5 PI (1964-78)

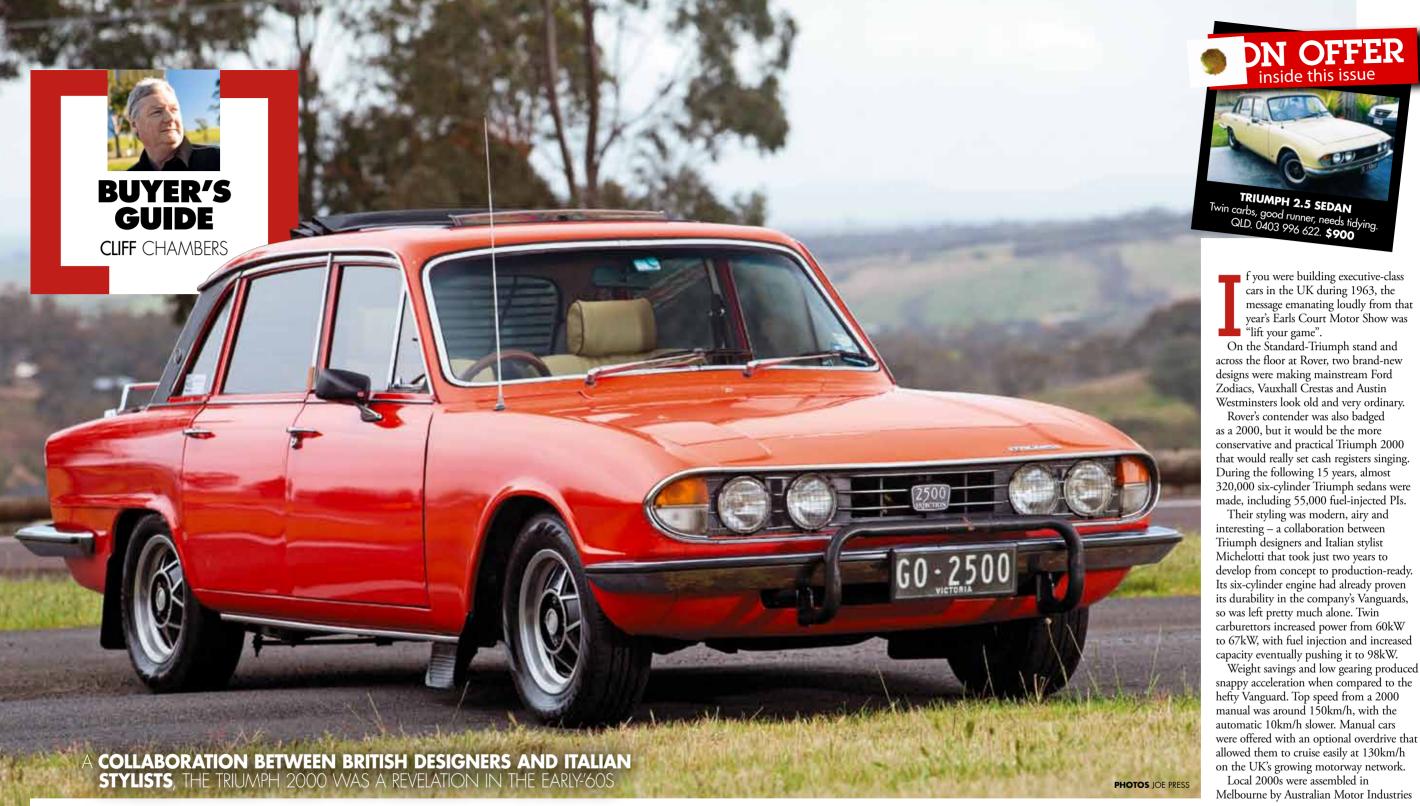
FAR LEFT 1969 Mark 1 2.5 Pl (oversteering) shows off Triumph's original Michelotti front LEFT 'Pl' stands for Petrol Injection; Aussieassembled 2.5 Pls featured metallic paint, vinylcovered C-pillars, trick wheels (or covers)

The PI introduced metallic paint to the Australian Triumph range, accompanied by vinyl-covered C-pillars and Rostyle wheel covers. In May 1970, the Mark 2 version was introduced featuring an elongated nose that echoed the new Triumph Stag, rectangular taillights and new bumpers.

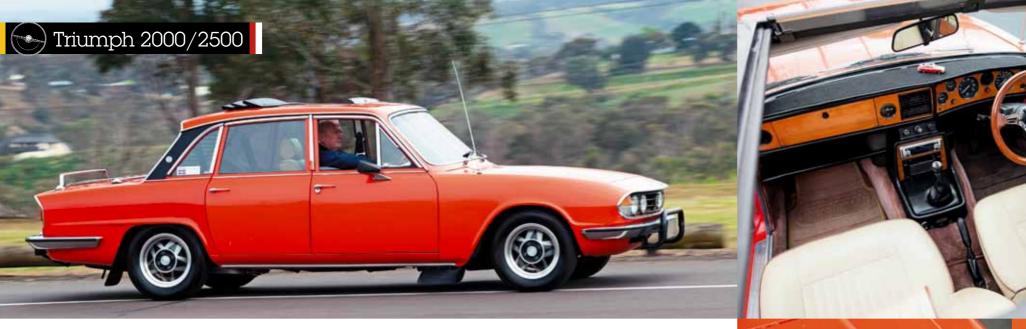
11 // Acceleration from manual cars isn't startling and carb-fed autos can be turgid. Our feature car had its auto replaced by a manual/overdrive

owner of our featured PI Mark 2 elected to have its original auto transmission replaced (at some expense) by a manual/overdrive. Four-speed fuel economy can better

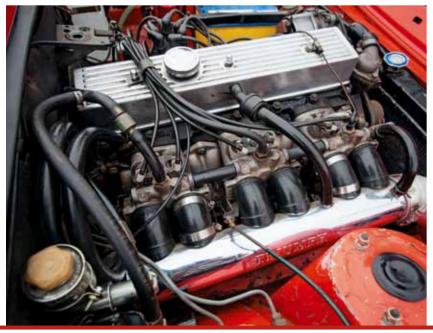
BELOW Triumph dropped troublesome Lucas fuel injection in 1975. Today, most engines have had their original Lucas parts replaced to make them both powerful and reliable

Triumph gave up on the fuel injected PI in mid-'75 and by 1976, only the 2500TC remained. But a flagship Triumph was revived in June '77 - the 2500S. Its engine was shifted marginally sideways to provide clearance for larger SU carburettors and a new exhaust manifold, but with power boosted by just 5kW, the effort seemed hardly worthwhile.

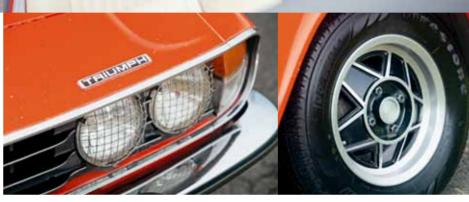
Ride quality, providing you don't go too extreme with the suspension fiddles, is brilliant. The downside of long-travel springs is body roll which manifests more ABOVE The 2000 was lauded for great all-'round visibility when launched - sunroof on this 2500 Injection Mark 2 magnifies that - and smaller aftermarket wheel sharpens the steering; headlight grilles good for country roads; stylish 14-inch mags pinched from Stag sports car

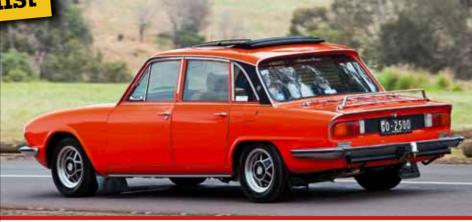
ABOVE Fully equipped in this instance means not only a fold-back sunroof but also rear venetian, bootlid luggage rack, mudflaps, tow bar and front nudge bar!
